FACILITY COMPLIANCE INSPECTION REPORT

Division of Waste Management Solid Waste Section

Date of Site Inspection: 26 October 2011

Dare County Transfer Station
1603 Cub Road
Manns Harbor, NC 27953

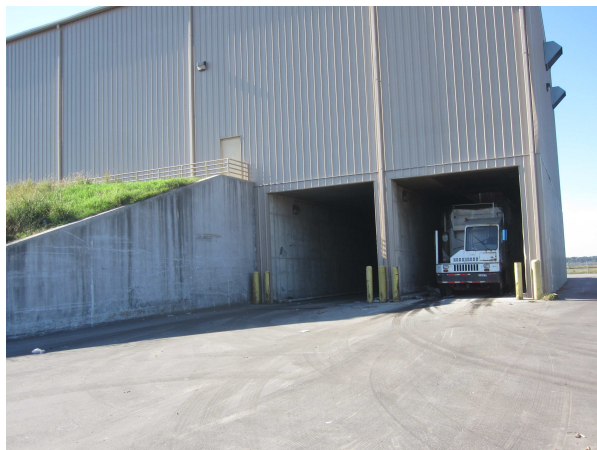
Access to loading bays

- 14) The access area behind the push walls is cleaned of overflow waste daily.
- 15) The trailer loading area is cleaned of any waste overflow as trailers are removed from the bays for transfer and at the end of the workday.

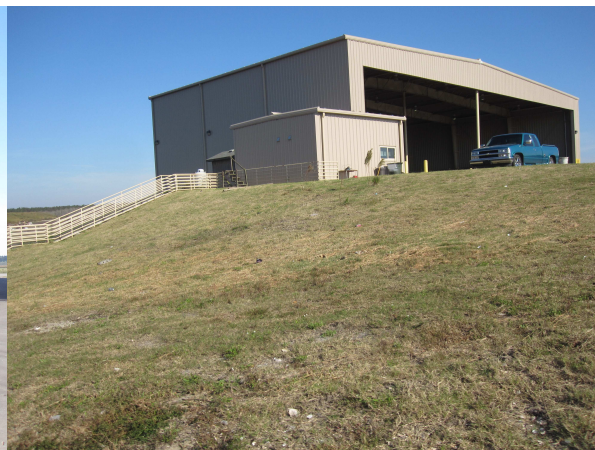
Stable access around facility

- 19) Access around the facility is stable and no areas of erosion were noted during this audit.
- 20) White goods are removed to the Dare County C&D Landfill, permit #28-03, White Goods Management Area.

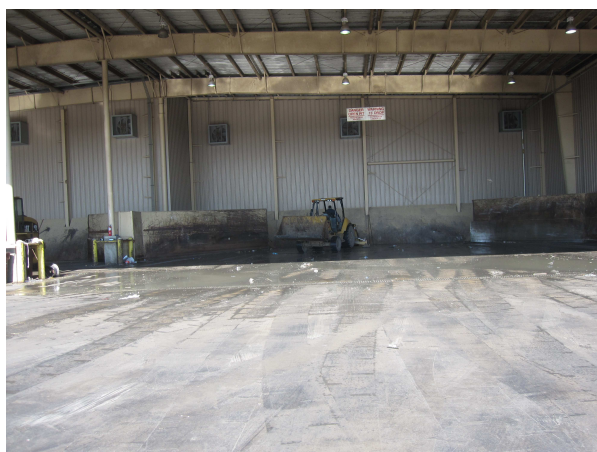
Well maintained tipping floor

- 11) The tipping floor is cleaned and washed down daily.

- 16) Leachate is collected on-site in above ground storage tanks and is pumped down and hauled to the Elizabeth City Wastewater Treatment Plant as needed. Overall, leachate and the leachate collection system appear to be well managed at this time. Please ensure that the leachate drain in the tipping floor is kept clean to ensure adequate drainage and flow of leachate to the storage system.

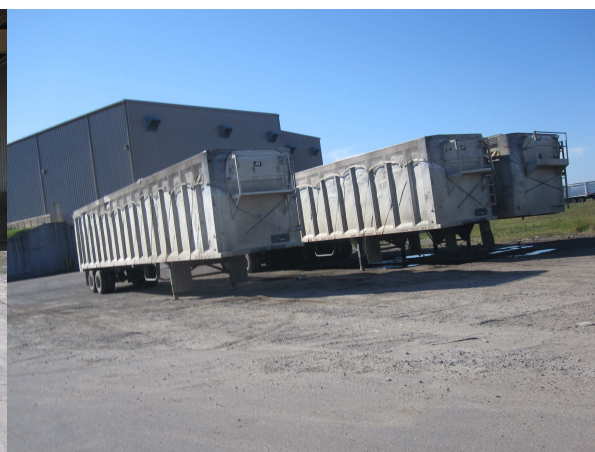
Adequate supply of trailers maintained on-site

- 17) This facility maintains an adequate number of trailers on site to properly manage the volume of waste received during operating hours.
- 18) Windblown debris is being well managed at this time; no wind blown debris was noted as leaving the site.
